Recreational Use Attainability Analysis of Five Creeks along the Little Brazos River: Walnut Creek (1242O), Mud Creek (1242K), Pin Oak Creek (1242L), Spring Creek (1242M), and Campbells Creek (1242I)

Prepared for:
Texas State Soil and Water Conservation Board
Project 08-54

Data Collected by:
Brazos River Authority

June 2014

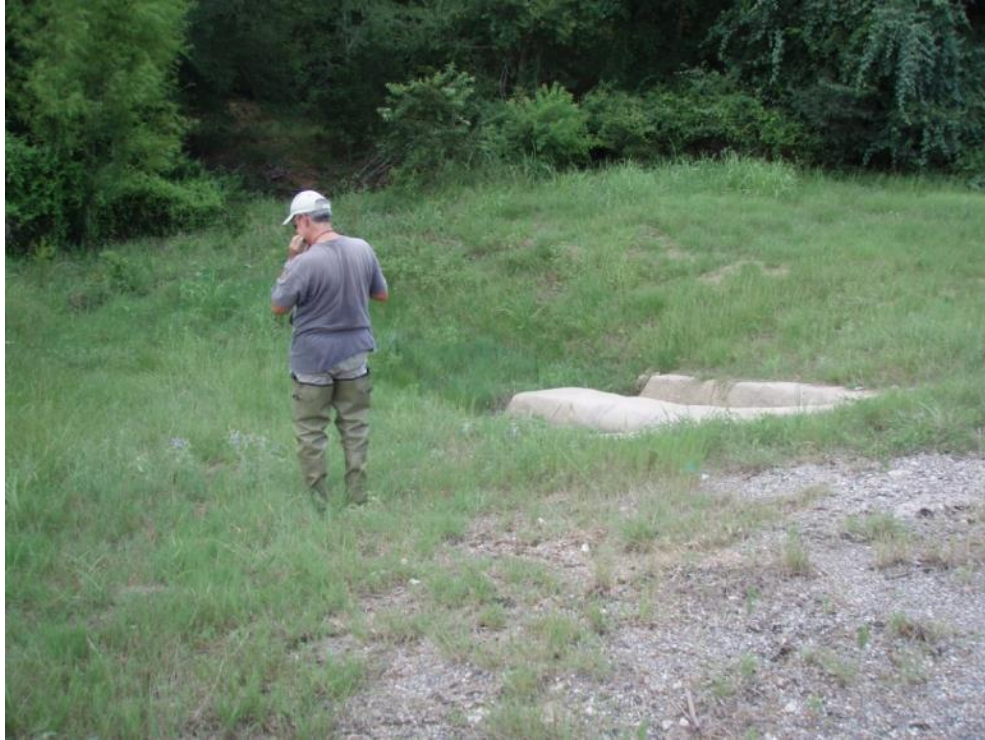
Figure 7.12 Photograph of Spring Creek Site 99914 taken on June 29, 2010, showing the dry and grassy creek bed at the downstream side of the FM 391 crossing. BRA personnel in photograph.

Spring Creek at Site 99914 was visited on June 29 and August 18, 2010. Located northeast of Hearne, Texas, in Robertson County, this site was accessible from the right-of-way of FM 391. A culvert was the only sign of the creek's existence (Figures 7.12) which was almost entirely dry in June and completely dry in August. The average thalweg depth during the June survey 0.02 m. The 300-m reach was located downstream of the road crossing on private property and was not fenced. A fence was constructed on the upstream side of the road crossing between surveys. Terrestrial vegetation was thick in the channel in places and would be the only considerable obstacle to wading if water were present. Figures 7.13 and 7.14 depict the appearance of the site during each of the surveys.

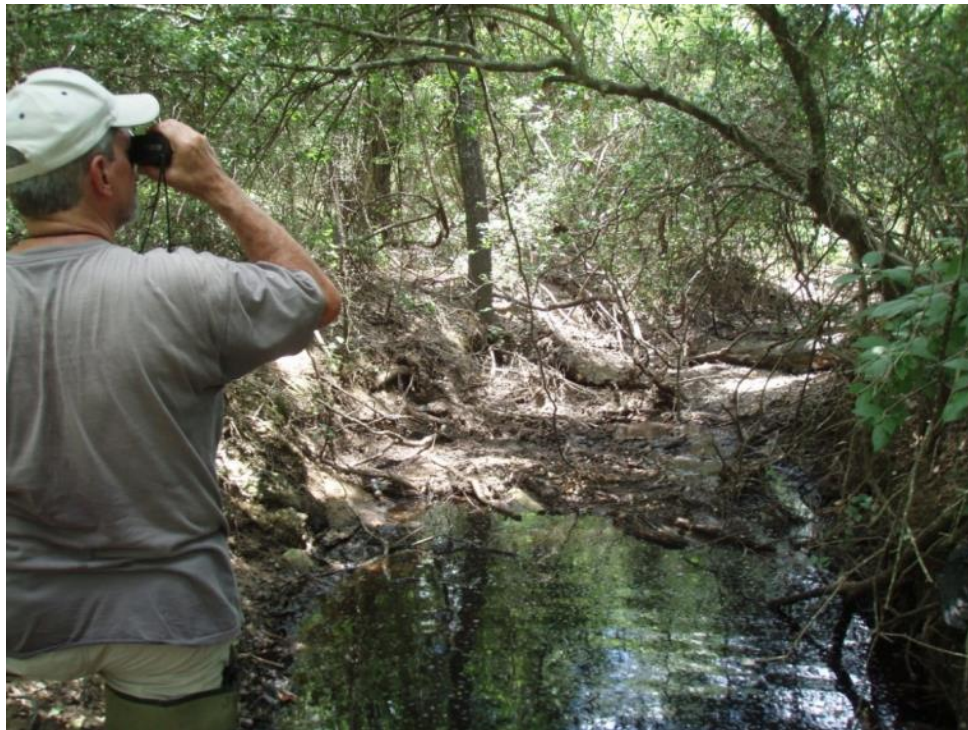
Figure 7.13 Photograph of Spring Creek Site 99914 taken on June 29, 2010, the downstream view at the 30-m transect. BRA personnel in photograph.

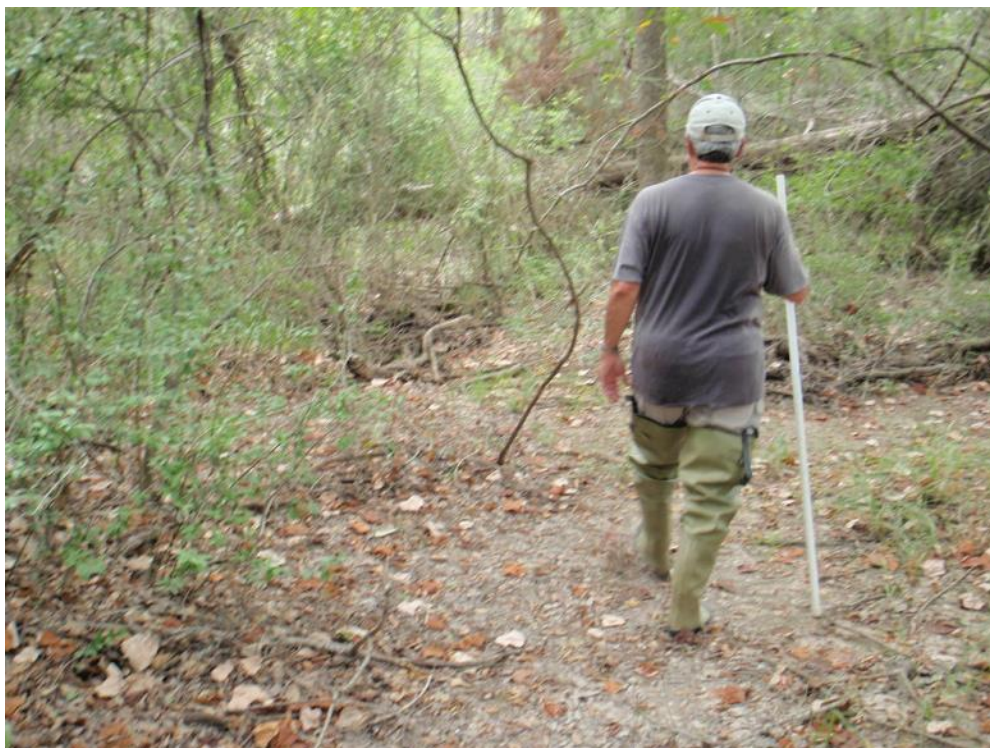
Figure 7.14 Photograph of Spring Creek Site 99914 taken on August 18, 2010, the downstream view of the 150-m transect. BRA personnel in photograph.

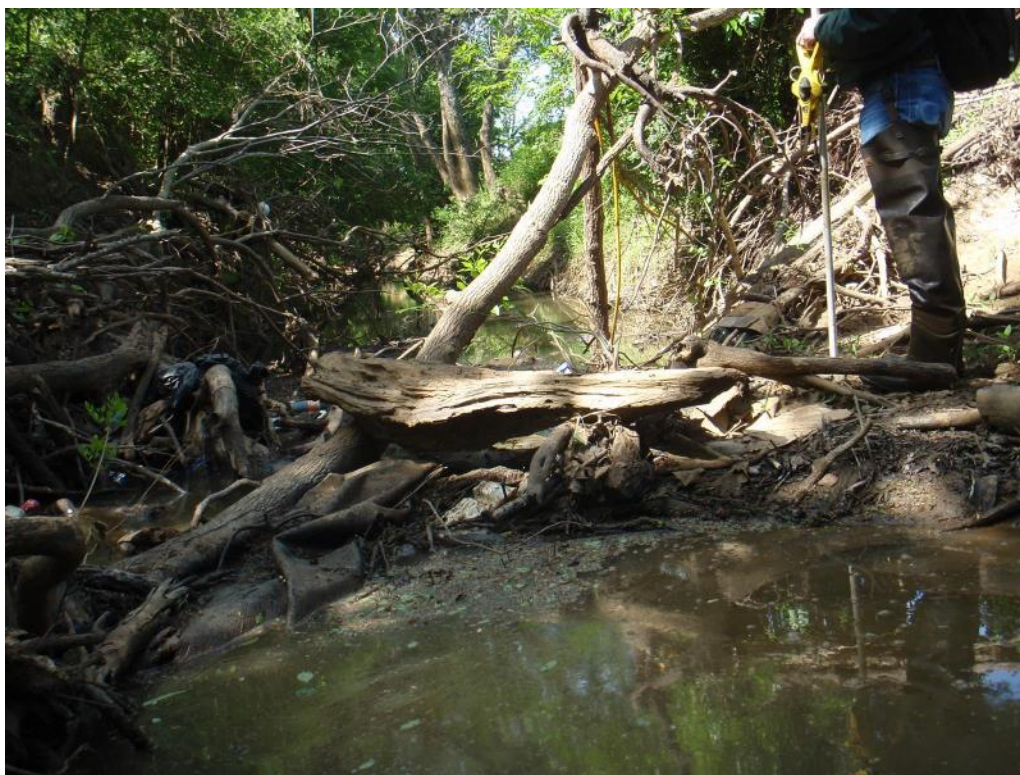
Figure 8.2 Photograph of Campbells Creek Site 99915 taken on April 9, 2010, showing log jam near the 150-m transect.

Campbells Creek at Site 99915 was visited on April 9 and August 12, 2010. Located southeast of Hearne, Texas, in Robertson County, this site was accessible from the right-of-way of Mumford Benchley Road but was located primarily within a fenced private pasture. The riparian zone of both banks was narrow, generally 5 - 20 m. Access to the stream was considered moderately easy during the second survey due to road access but moderately difficult during the first survey due to fencing and steep banks. Figures 8.2 and 8.3 depict the general appearance of the site and water quality during each of the surveys.

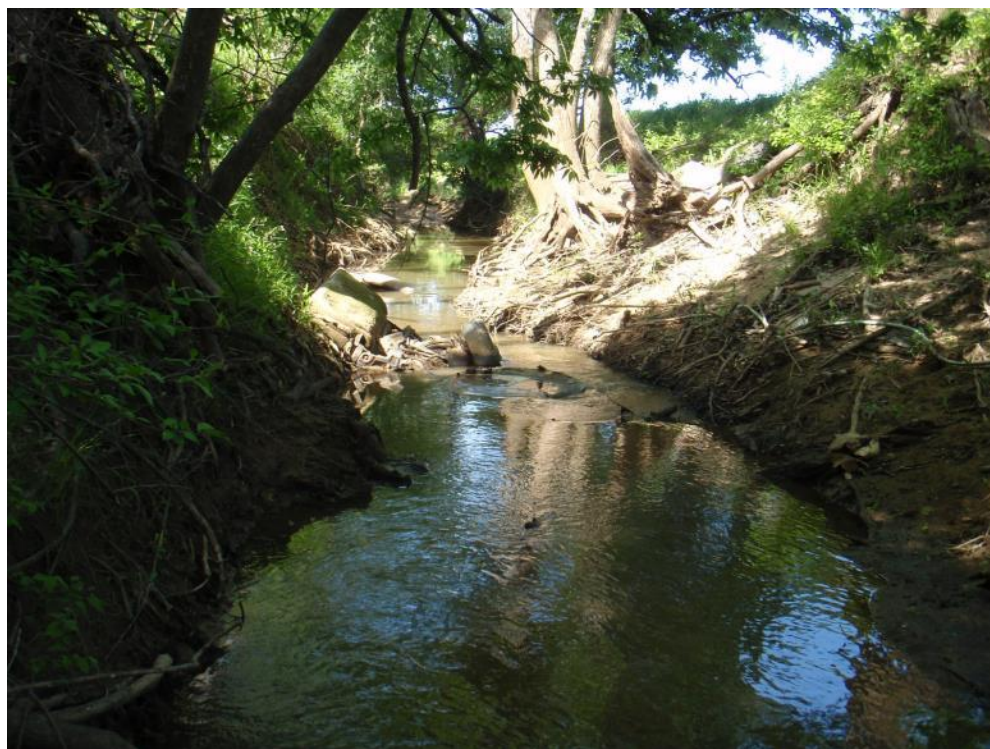
Figure 8.3 Photograph of Campbells Creek Site 99915 taken on April 09, 2010, the downstream view of the 30-m transect.

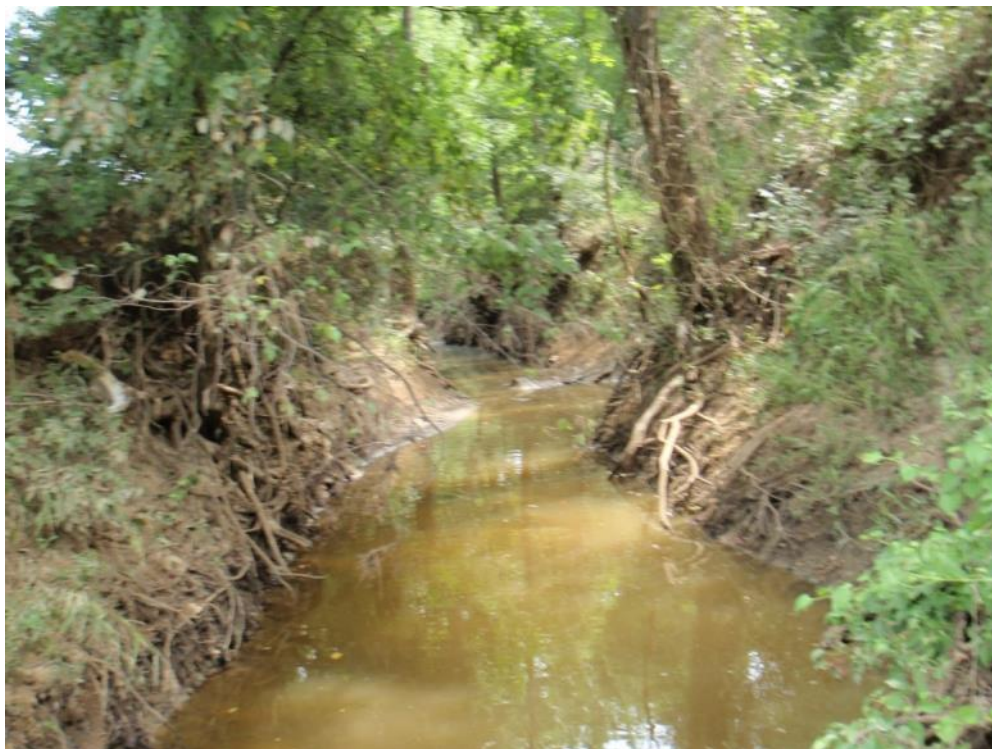
Figure 8.4 Photograph of Campbells Creek Site 99915 taken on August 12, 2010, the upstream view of the 150-m transect.

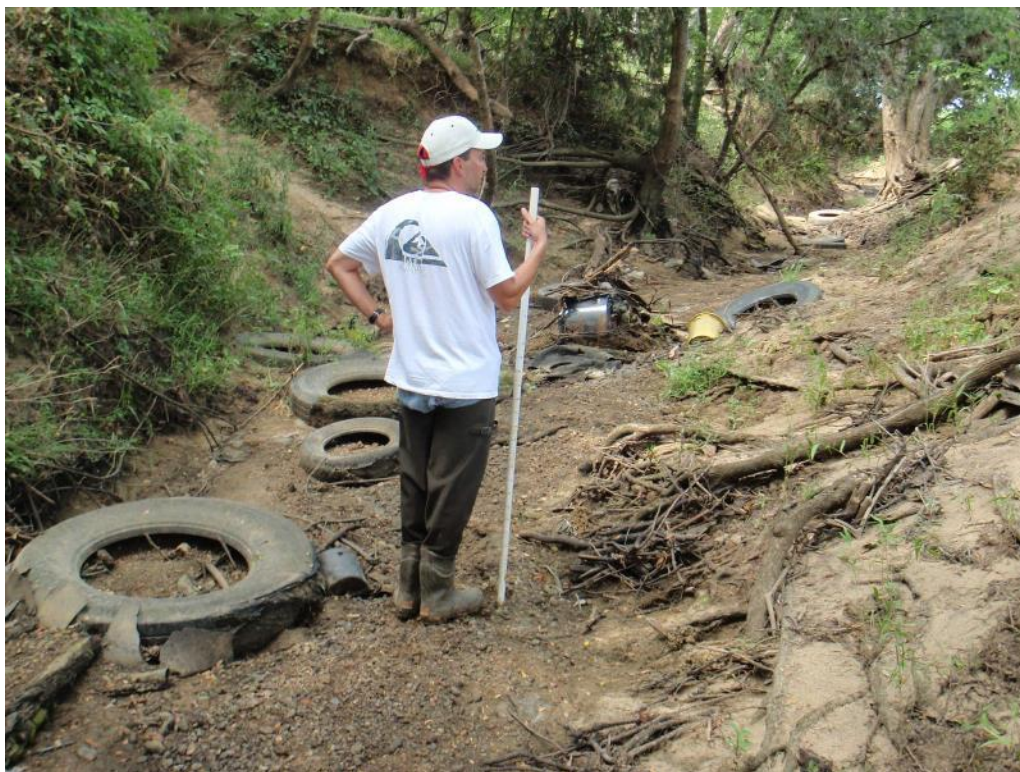
Figure 8.5 Photograph of Campbells Creek Site 99915 taken on August 12, 2010, showing trash near the 30-m transect. BRA personnel in photograph.

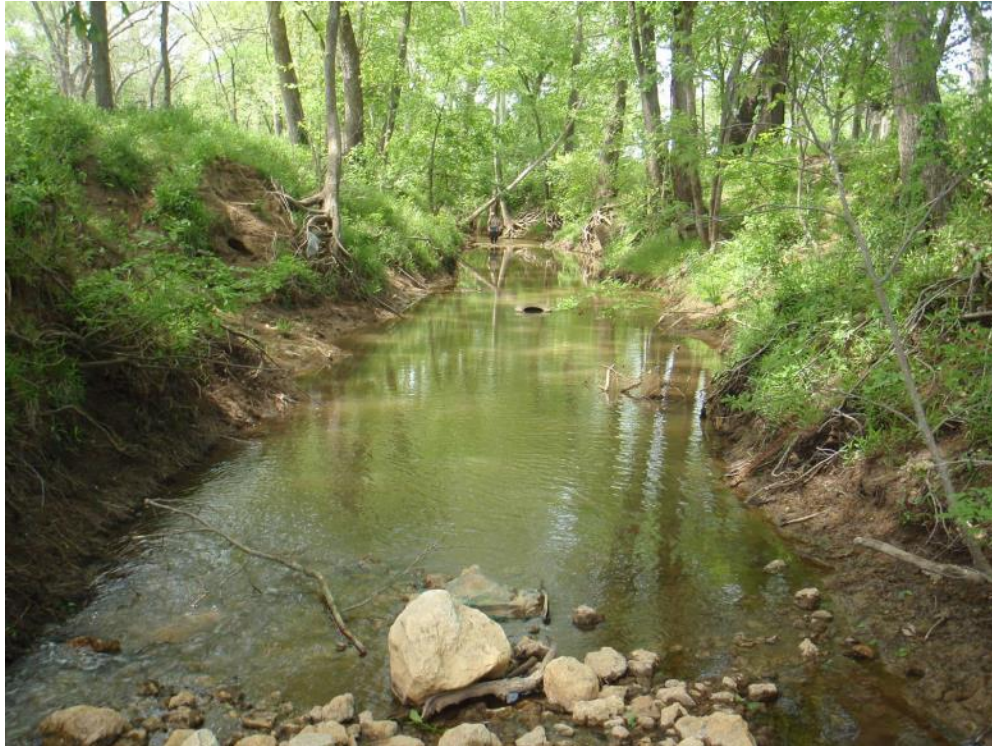
Figure 8.6 Photograph of Campbells Creek Site 16395 taken on April 9, 2010, the downstream view of the 150-m transect.

Campbells Creek at Site 16935 was visited on April 9 and August 12, 2010. The surveys began on the upstream side of Old Hearne Road about 75 m downstream of SH 6 / US 190. Public access is restricted by private property fencing at SH 6/US 190 and at Old Hearne Road. Most of the 300-m reach was accessible only via private land. These obstacles notwithstanding, access was moderately difficult during the first survey due to steep banks and moderately easy during the second survey (Table 8.7). The riparian on both shores was generally forest, though the tree line was narrow (generally < 10 m), and the stream corridor was principally pasture and cultivated land. Figures 8.6 and 8.7 depict the appearance of the site during each of the surveys.

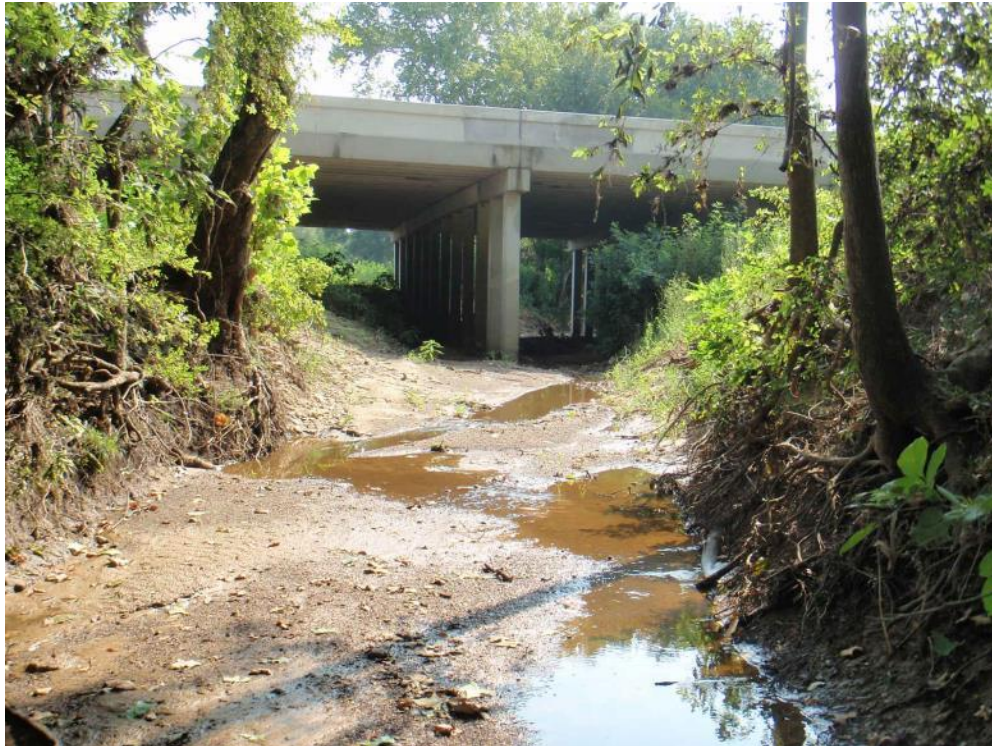
Figure 8.7 Photograph of Campbells Creek Site 20385 taken on April 9, 2010, the upstream view of the 150-m transect.

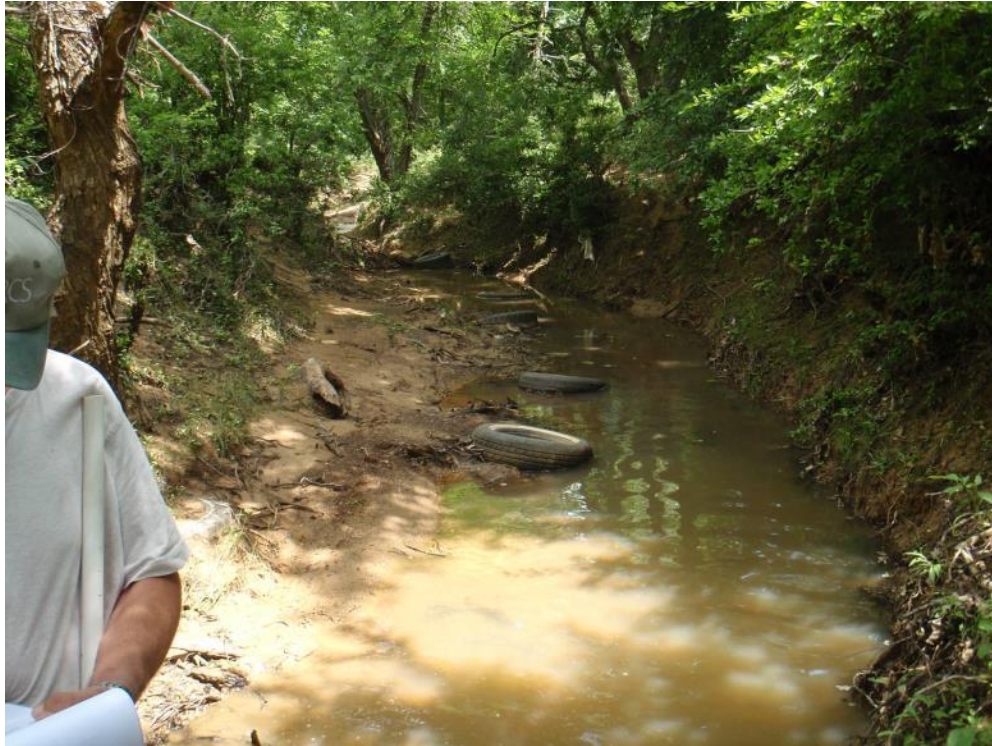
Figure 8.8 Photograph of Campbells Creek Site 20561 taken on May 21, 2010, the upstream view of the 150-m transect. BRA personnel in photograph.

Campbells Creek at Site 20561 was visited on May 21 and August 31, 2010. Located southeast of Hearne, Texas, in Robertson County, this site was accessible from the right-of-way at the Jack Rabbit Lane crossing. The site, entirely within private property with a posted no trespassing sign, is located in a pasture dominated corridor with trees and shrubs in the immediate vicinity of the stream channel (Table 8.6). Stream access was moderately easy despite some fencing at the road crossing and occasionally steep banks. Figures 8.8 and 8.9 show the general appearance of the stream during the two surveys.

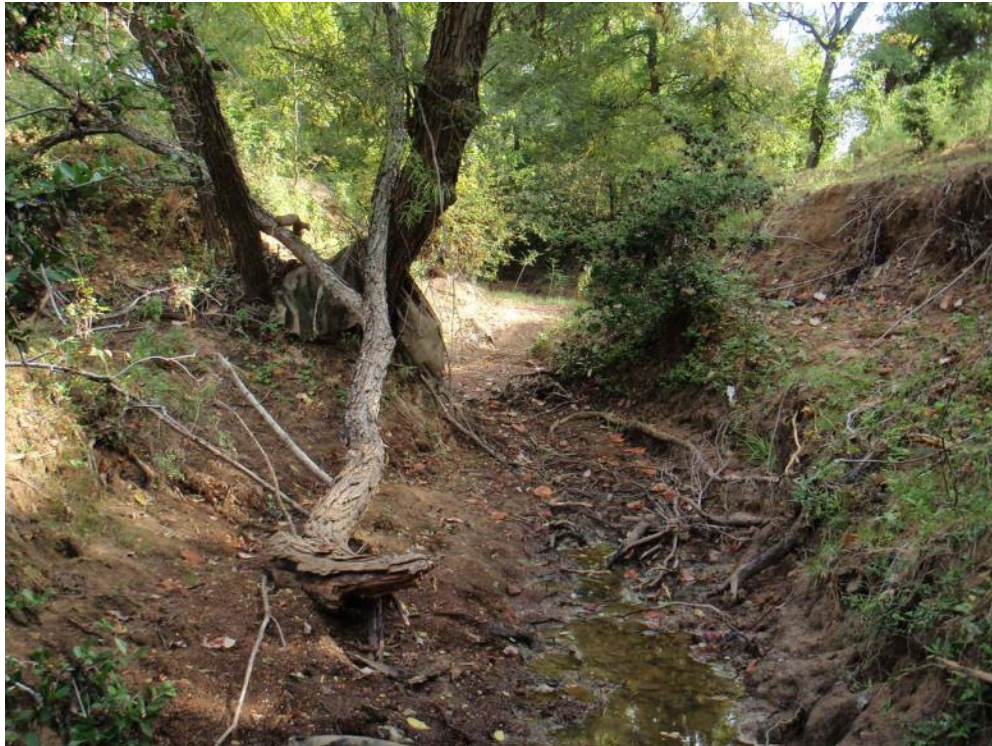
Figure 8.9 Photograph of Campbells Creek Site 20561 taken on August 31, 2010, the upstream view of the 150-m transect.

Site 20561 was wadeable for the entire 300-m reach although fencing at the road crossing posed an obstacle to traversing the channel. Only one significant pool was present and it was 10 m in length, 2 m wide, and 0.75 m deep. The average thalweg depth range was 0.25 m during the first survey and 0.12 m during the second survey when most of the channel was dry and only shallow, disconnected pools were present (Tables 8.8). The maximum and minimum widths of the stream were 2.3 m and 0.7 m, respectively, during the first survey and 0.5 m and 0.0 m (dry) during the second survey.

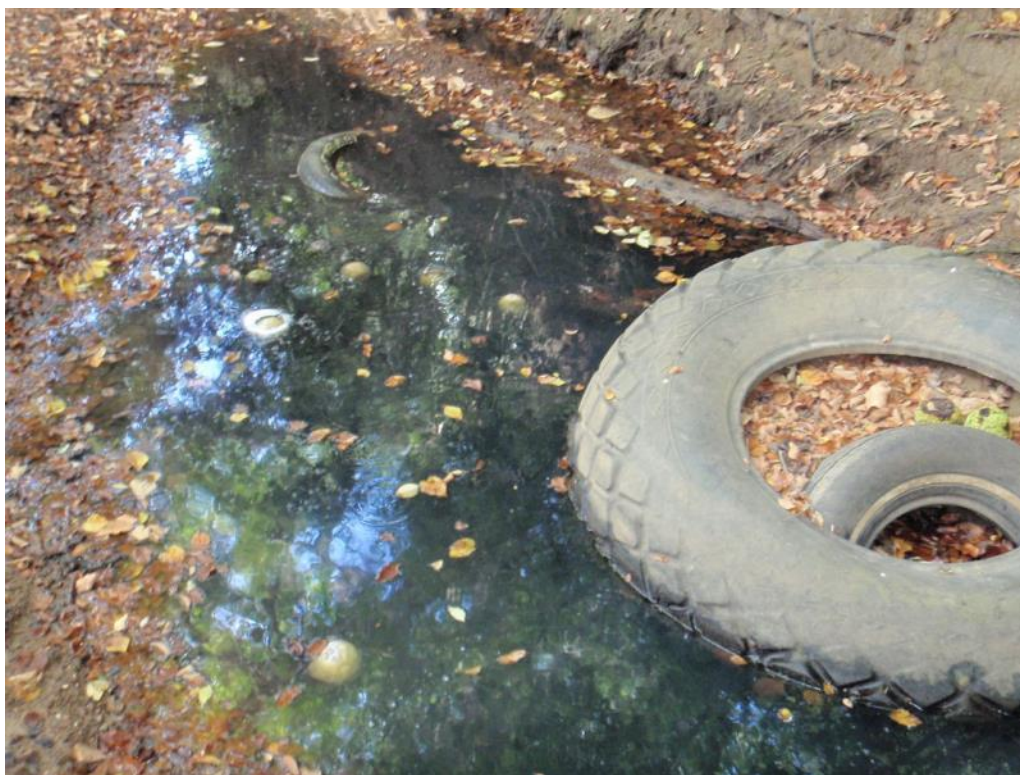
Figure 8.10 Photograph of Campbells Creek Site 20561 taken on August 31, 2010, the downstream view of the 300-m transect.

The aesthetic appearance of the water and wildlife observations for the site during each survey are provided in Tables 8.10 and 8.11, respectively. Cows were observed during the first survey along with tracks and fecal deposits. During the second survey, only tracks were observed, presumably because there was so little water for the cows to access. Aquatic vegetation was rare in May and absent in August. Algae was rare during both surveys. Odor was absent during the first survey but abundant in August, probably due to stagnating pools. Water color was brown to black during both surveys (Figure 8.10) and scum was present in August on the stagnant pools. Fine sediments dominated the substrate during both surveys. Garbage was common to abundant and included tires, batteries, and household trash indicating that the site was commonly used as a dumping area. No indications of human presence were otherwise found.

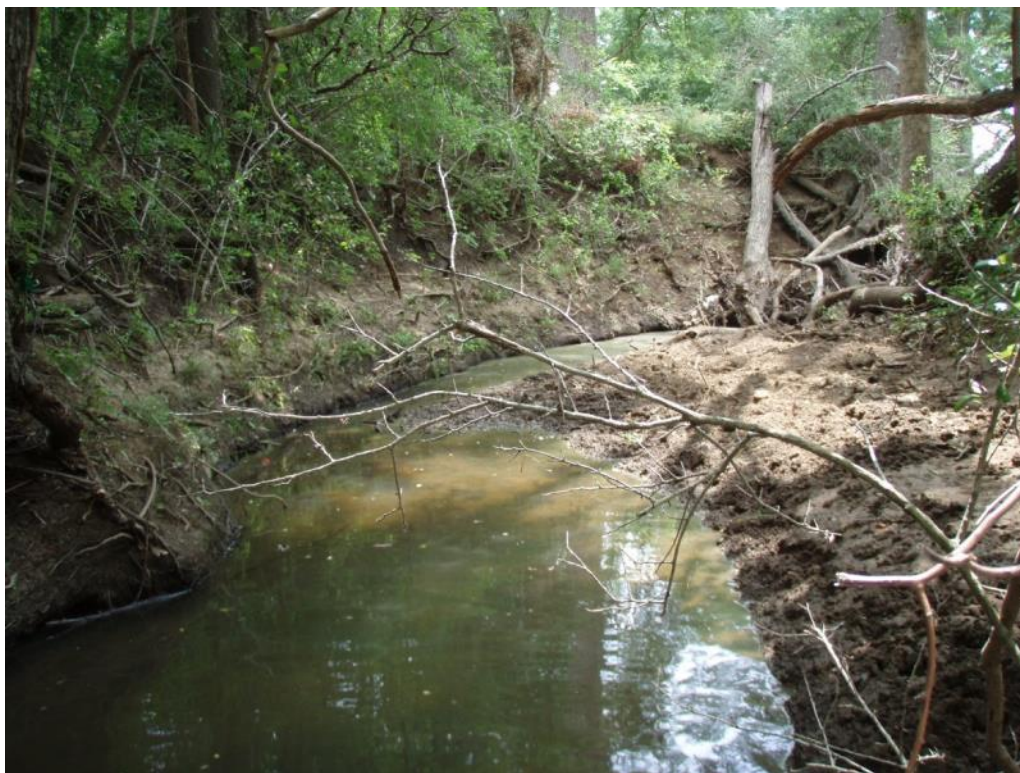
Figure 8.11 Photograph of Campbells Creek Site 99916 taken on June 23, 2010, the downstream view of the 150-m transect.

west of Old San Antonio Road south of Castenson Road. In addition to being entirely on fenced private property with a no trespassing sign, access to the banks was deemed moderately difficult on account of steep banks and dense trees and brush that lined the riparian zone (Table 8.7 and Figure 8.11). Figures 8.11 and 8.12 depict the general appearance of the site during the June and August surveys.

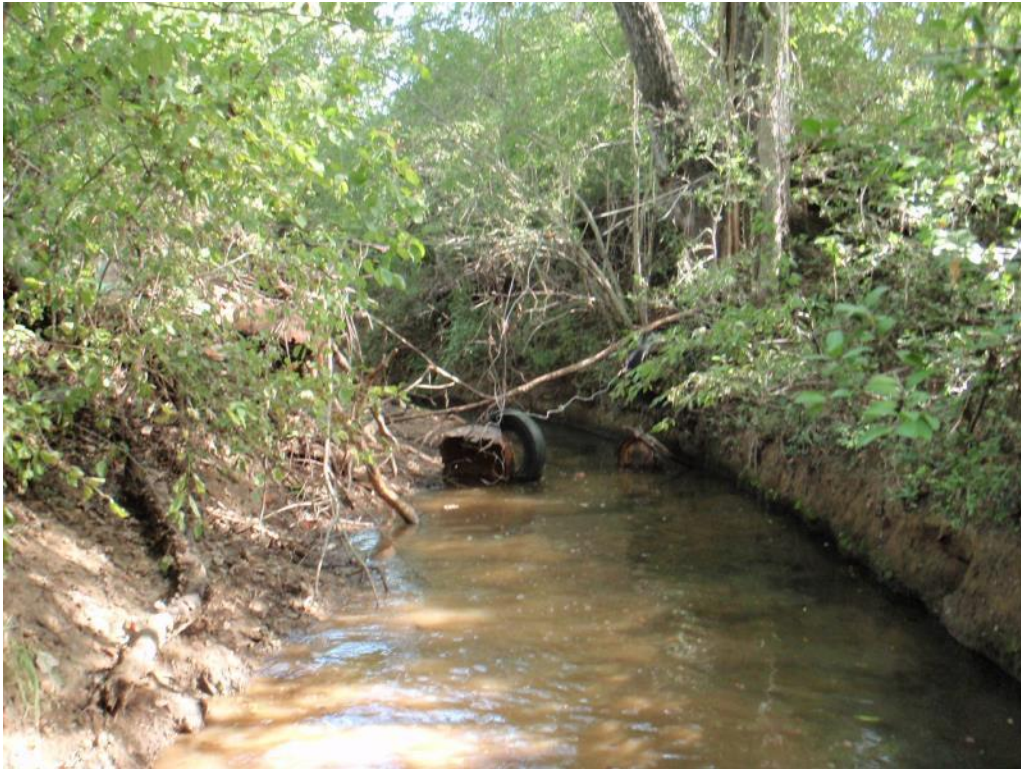
Figure 8.12 Photograph of Campbells Creek Site 99916 taken on August 24, 2010, the upstream view of the 30-m transect.

Flow during the first survey was sluggish but normal for the site in June. In August flow was almost unmeasurable. The site was wadeable for the full 300 m with an average depth of 0.21 m in June and 0.30 m in August. Significant pools were only present in June (Table 8.16). The typical average width of the site during the first survey was 2.0 m and 1.0 m during the second survey. Tree limbs and snags were a major obstruction in the stream channel at some locations (Figure 8.13).

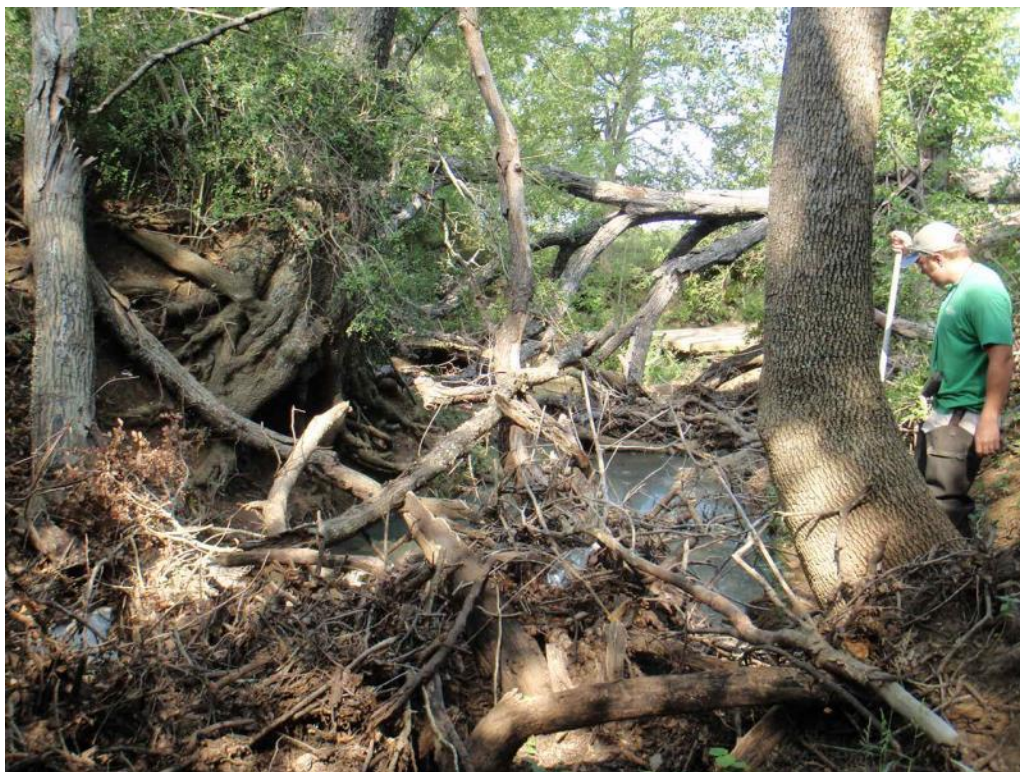
Figure 8.13 Photograph of Campbells Creek Site 99916 taken on August 24, 2010, showing snag obstruction downstream of the 150-m transect. BRA personnel in photograph.

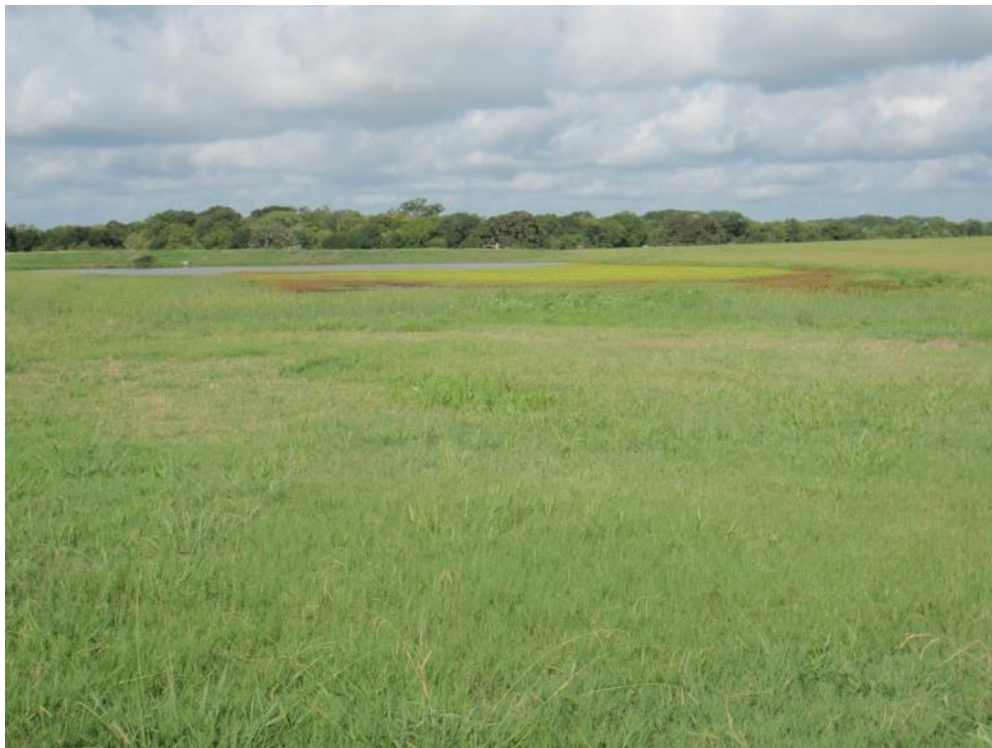
Figure 8.14 Photograph of Campbells Creek Site 99917 taken on August 9, 2010, the downstream view of the 150-m transect showing the stock pond.

Campbells Creek at Site 99917 was visited on August 09 and August 24, 2010. Located southeast of Hearne, Texas, in Robertson County, this site was only accessible from a private road west of Old San Antonio Road north of Castenson Road. The reach is entirely on private land in a cow pasture, and the shallow depression in the land that represents the channel carries flow into a stock pond only during rain. The lower half of the reach is represented by the stock pond. No fences inhibit access to the channel because it is in the middle of a field but access to the private property is restricted by fencing. Figures 8.14 and 8.15 depict the appearance of the site during each of the surveys.

Water was never present except in the stock pond at the downstream end of the reach. No measurements of width and depth for transects or pools were taken as the stream corridor was dry.

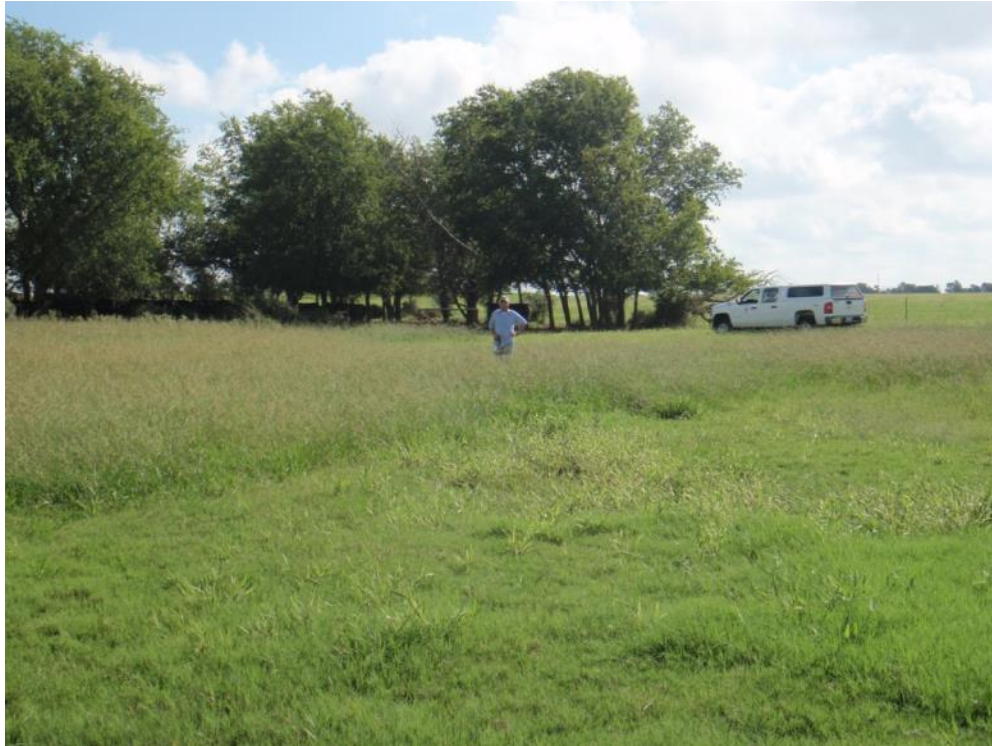
Figure 8.15 Photograph of Campbells Creek Site 99917 taken on August 24, 2010, the upstream view at the 150-m transect. BRA personnel in photograph.

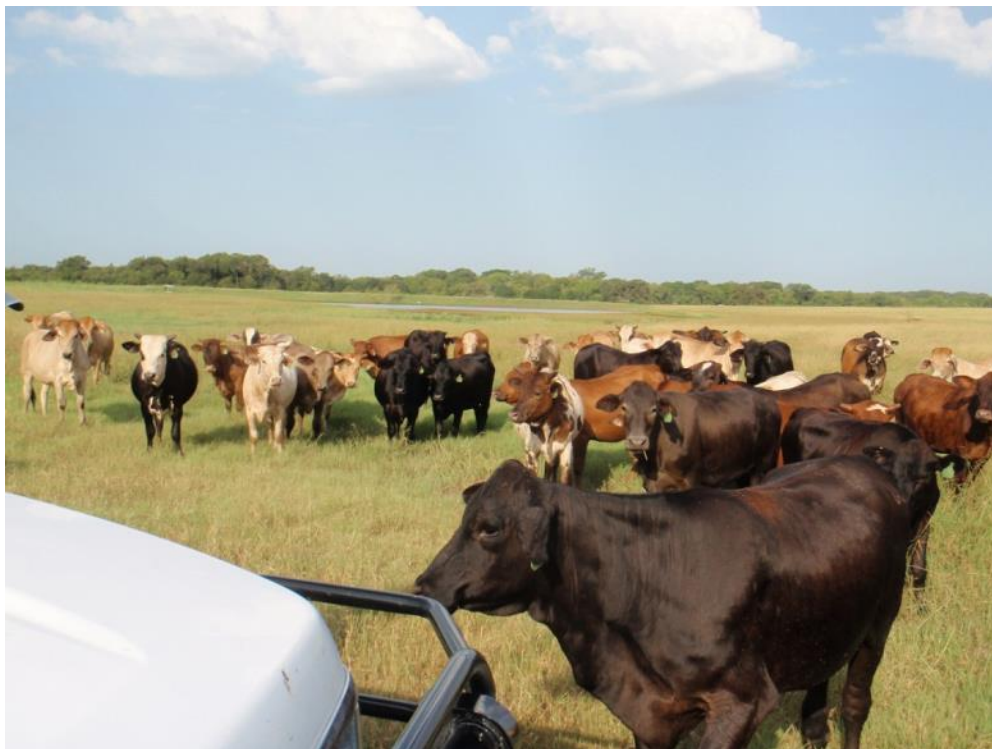
Figure 8.16 Photograph of Campbells Creek Site 99917 taken on August 24, 2010, the downstream view near the 150-m transect.

The aesthetic appearance of the water and wildlife observations for the site during each survey are provided in Tables 8.10 and 8.11. The only animals observed during both surveys were livestock (cows) and their presence was moderate to abundant (Figure 8.16). Aquatic vegetation and algae were common to abundant only at the edge of the stock pond. Trash was absent during both surveys. No evidence of recreation was observed within the reach.
